CONNECTICUT RIVER BASIN  
PITTSBURG, NEW HAMPSHIRE

**FIRST CONNECTICUT LAKE DAM****NH 00186****NHWRB 194.02**

**PHASE I INSPECTION REPORT**  
**NATIONAL DAM INSPECTION PROGRAM**

MAY 1979

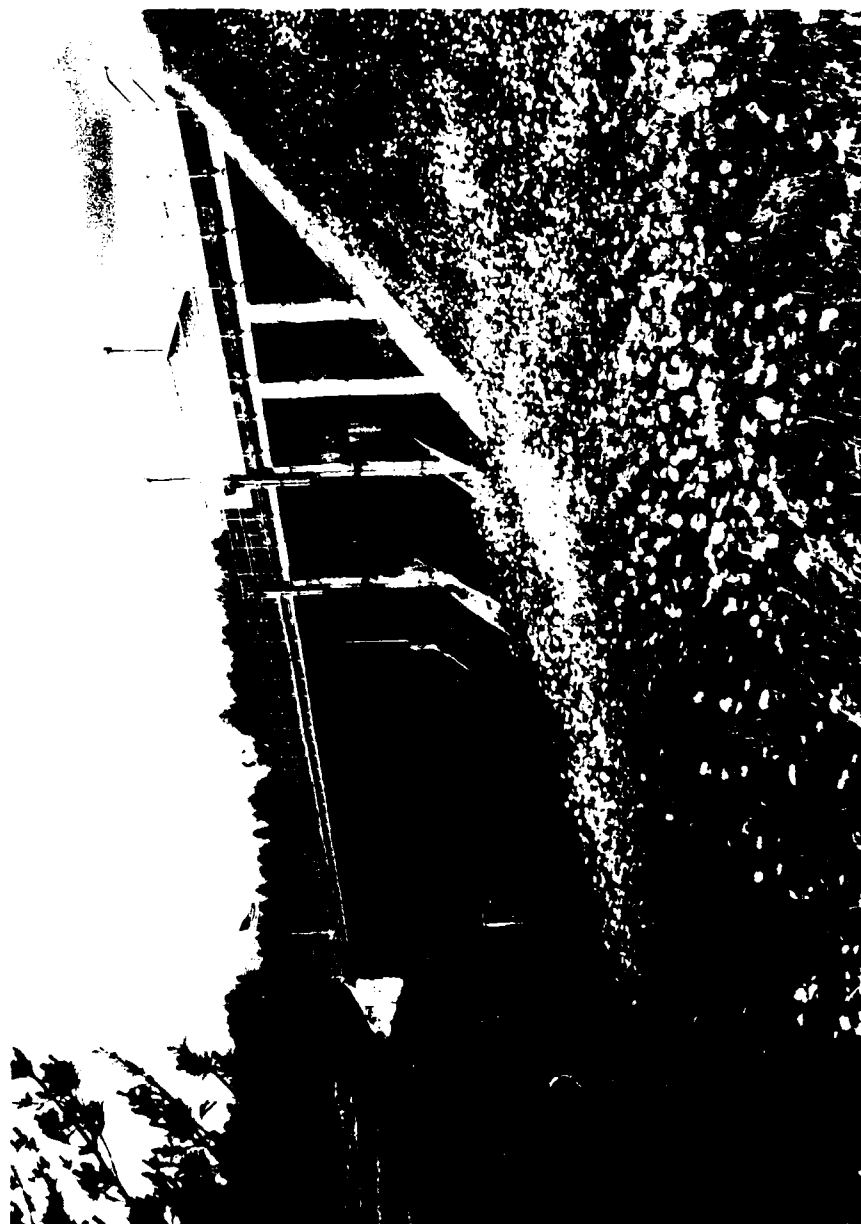
FIRST CONNECTICUT LAKE DAM, LOOKING NORTH ON THE DOWNSTREAM SIDE  
Negative No. 10-17

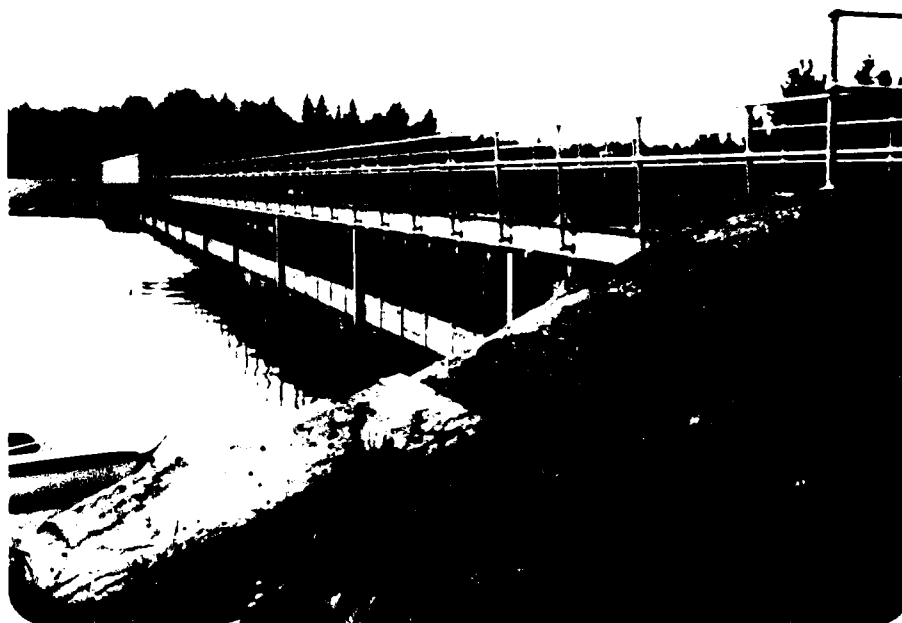
1. Upstream side of dam, showing flashboards and footbridge, looking south.

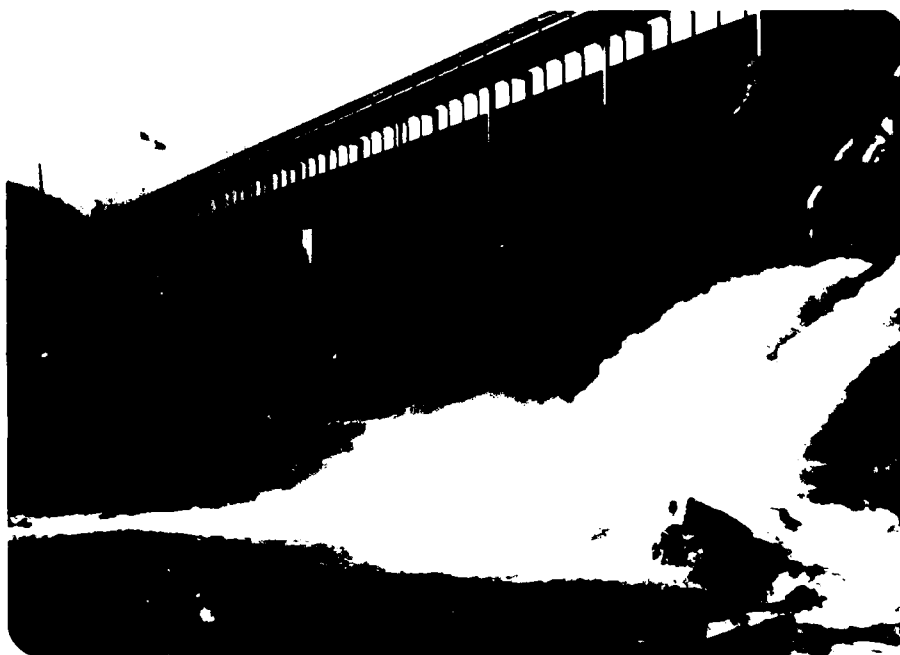
a. The poor condition of the concrete surface on the downstream face of the spillway and the north abutment.

2. Downstream side showing north bank and erosion of concrete facing.

b. All concrete surfaces should be repaired as continued deterioration could develop a serious problem.

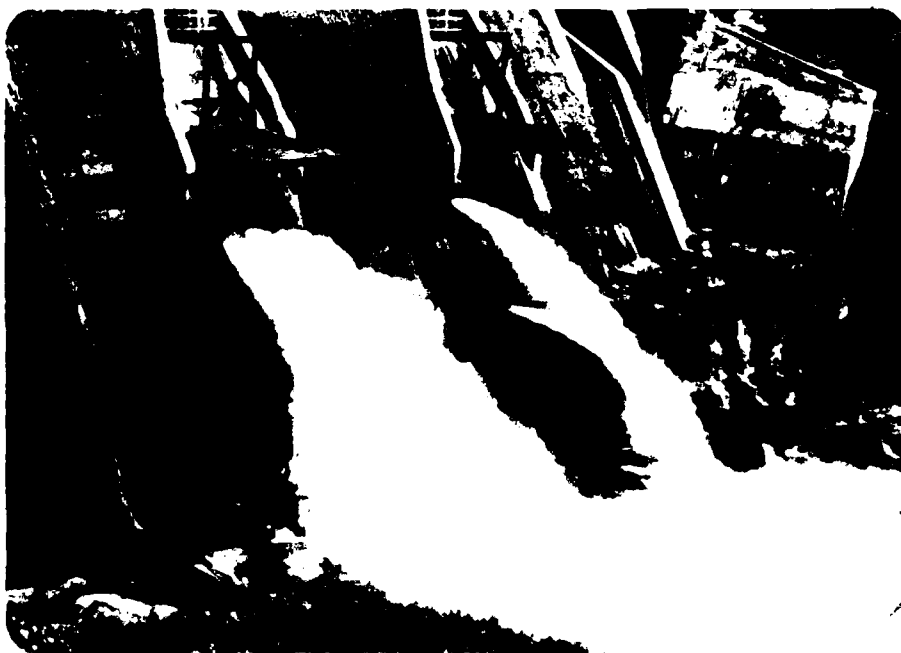
4. Downstream face with one gate open, fish pipe flowing, and south abutment at right.

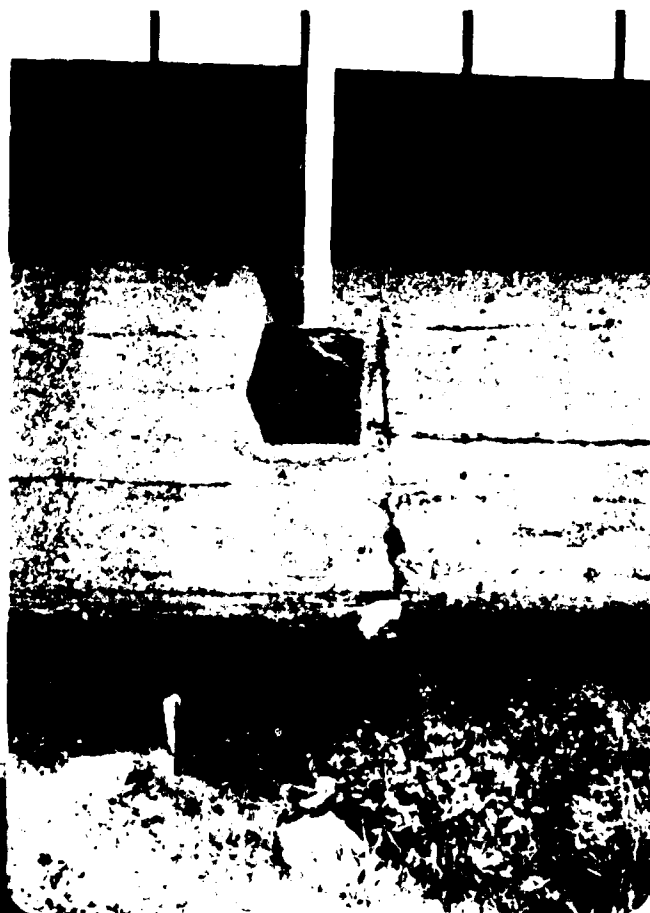
concrete surface of the north abutment was observed to be in poor condition with several badly spalled areas. In general, the concrete surface on the downstream side is in poor condition with numerous badly spalled areas. Joint alignment is generally good and no cavitation was noted. Efflorescence was noted on both the upstream and downstream sides of both abutments and the south retaining wall.

5. Downstream face, showing  
concrete erosion at  
construction joints.

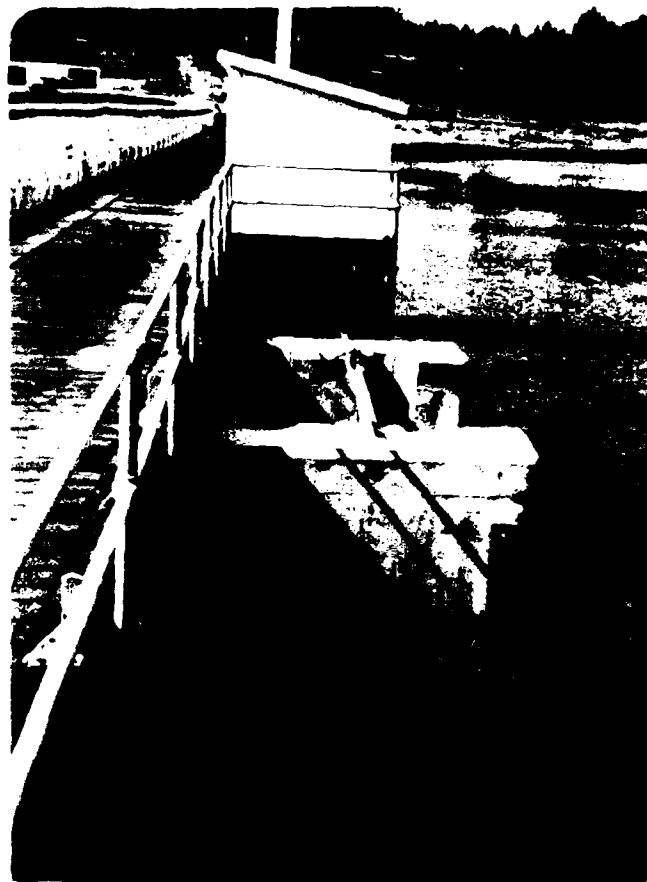
11. New concrete piers  
for log way near  
south end of dam.

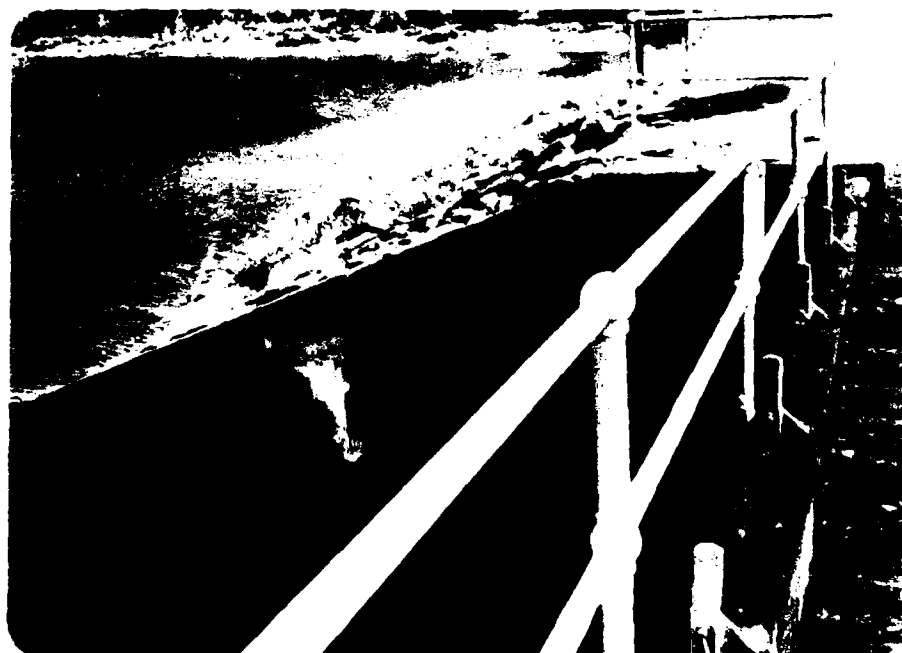
12. South abutment on the upstream side.
